# Home Report

Rooftops  
Glenree  
Alyth  
Blairgowrie  
PH11 8EA

# single survey

## survey report on:

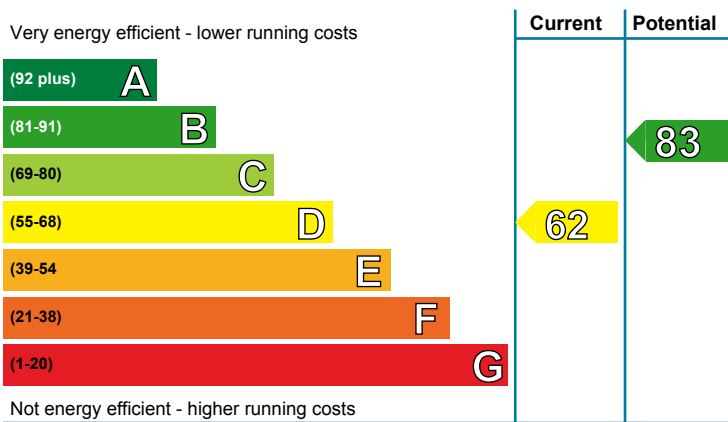
## Energy Efficiency Rating

This graph shows the current efficiency of your home, taking into account both energy efficiency and fuel costs. The higher this rating, the lower your fuel bills are likely to be.

Your current rating is **band D (62)**. The average rating for EPCs in Scotland is **band D (61)**.

The potential rating shows the effect of undertaking all of the improvement measures listed within your recommendations report.

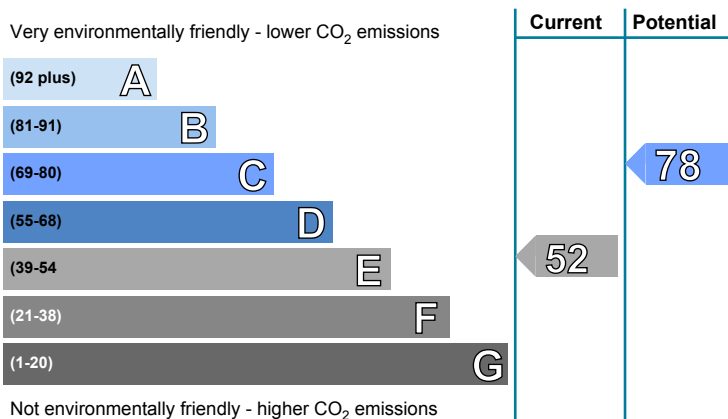
## Environmental Impact (CO<sub>2</sub>) Rating

This graph shows the effect of your home on the environment in terms of carbon dioxide (CO<sub>2</sub>) emissions. The higher the rating, the less impact it has on the environment.
