# Home Report

Rhoddybank  
Craighall Castle Drive  
Rattray  
Blairgowrie  
PH10 7HR

# single survey

<b>Property address</b>	Rhoddybank Craighall Castle Drive Ratray Blairgowrie PH10 7HR
<b>Customer</b>	Executry of the late Norman Laing
<b>Prepared by</b>	Graham + Sibbald LLP

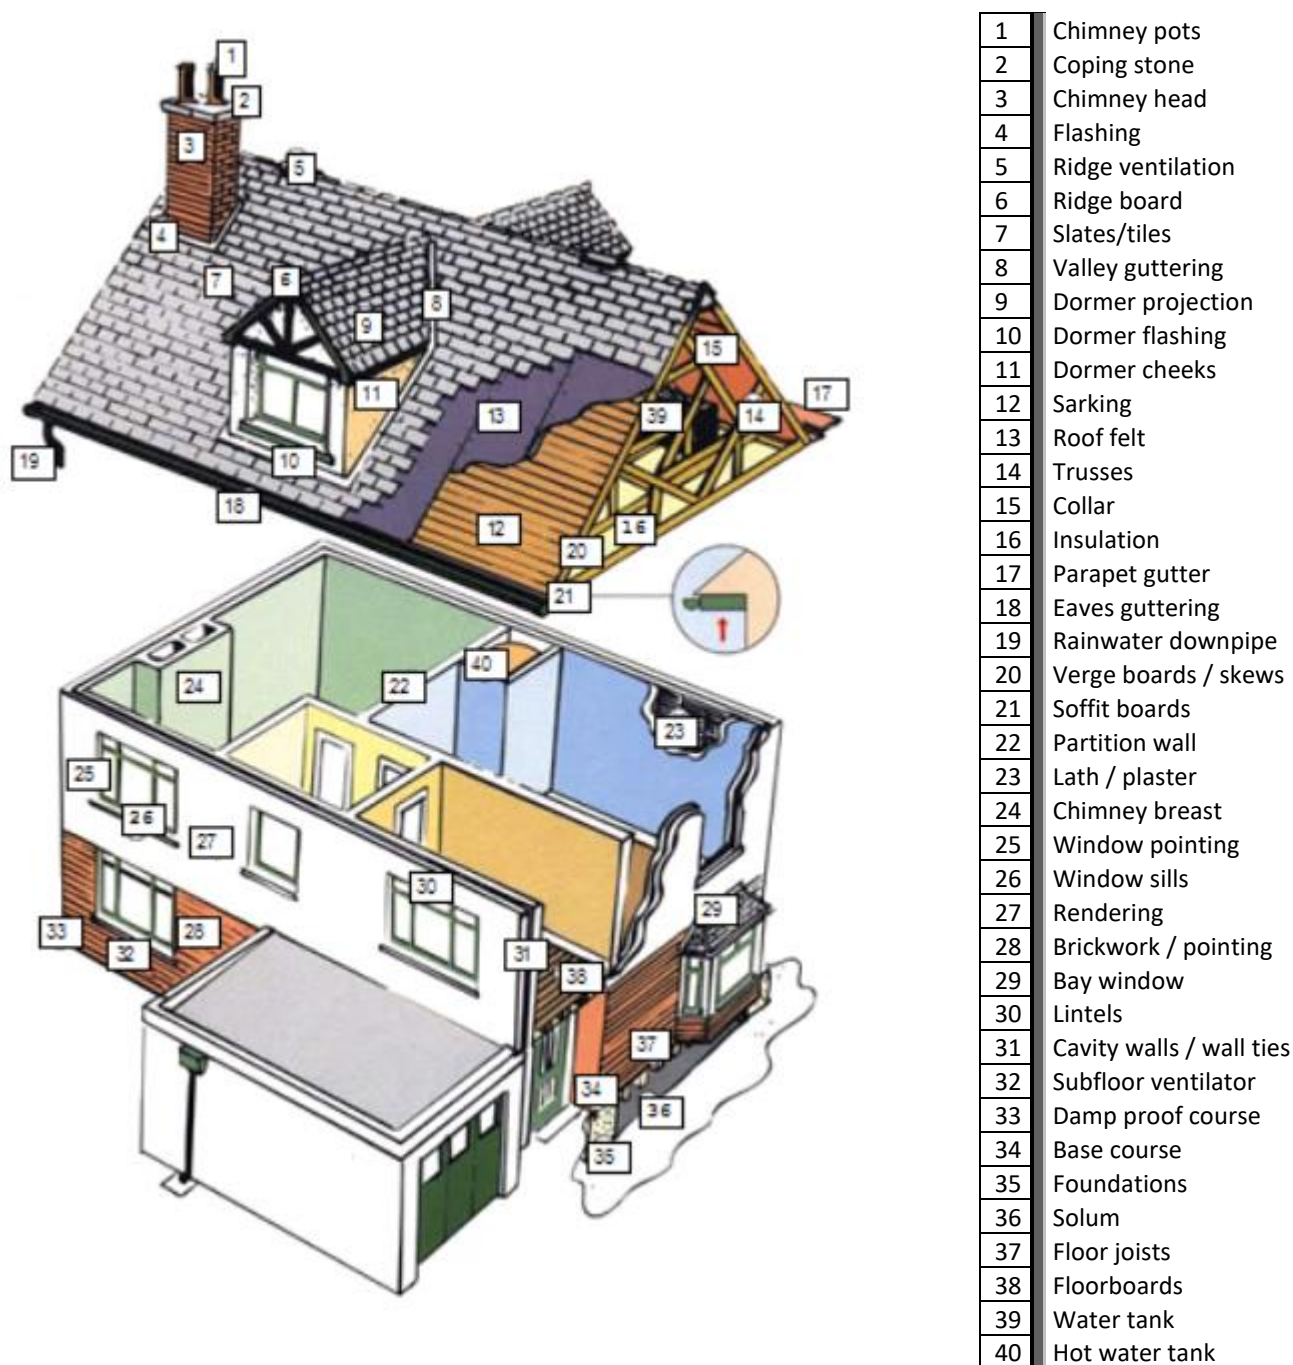
## Sectional Diagram showing elements of a typical house

Reference may be made in this report to some or all of the above component parts of the property. This diagram may assist you in locating and understanding these items.

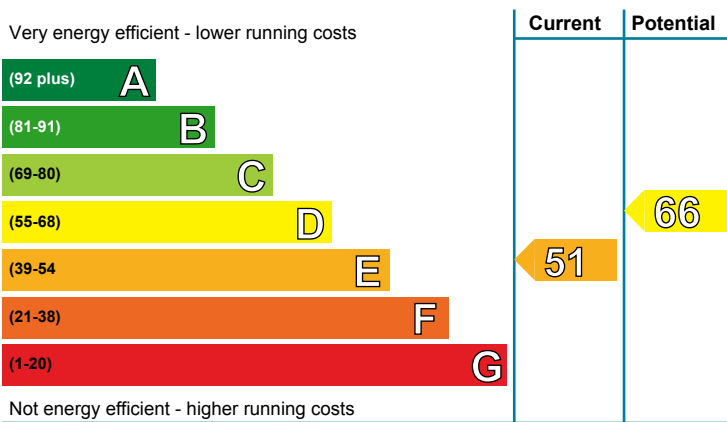
## Energy Efficiency Rating

This graph shows the current efficiency of your home, taking into account both energy efficiency and fuel costs. The higher this rating, the lower your fuel bills are likely to be.

Your current rating is **band E (51)**. The average rating for EPCs in Scotland is **band D (61)**.

The potential rating shows the effect of undertaking all of the improvement measures listed within your recommendations report.
