# Home Report

47 Springbank Road  
Alyth  
Blairgowrie  
PH11 8BG

# single survey

<b>Property address</b>	47 Springbank Road Alyth Blairgowrie PH11 8BG
<b>Customer</b>	Mary Lyall Executry
<b>Prepared by</b>	Graham + Sibbald LLP

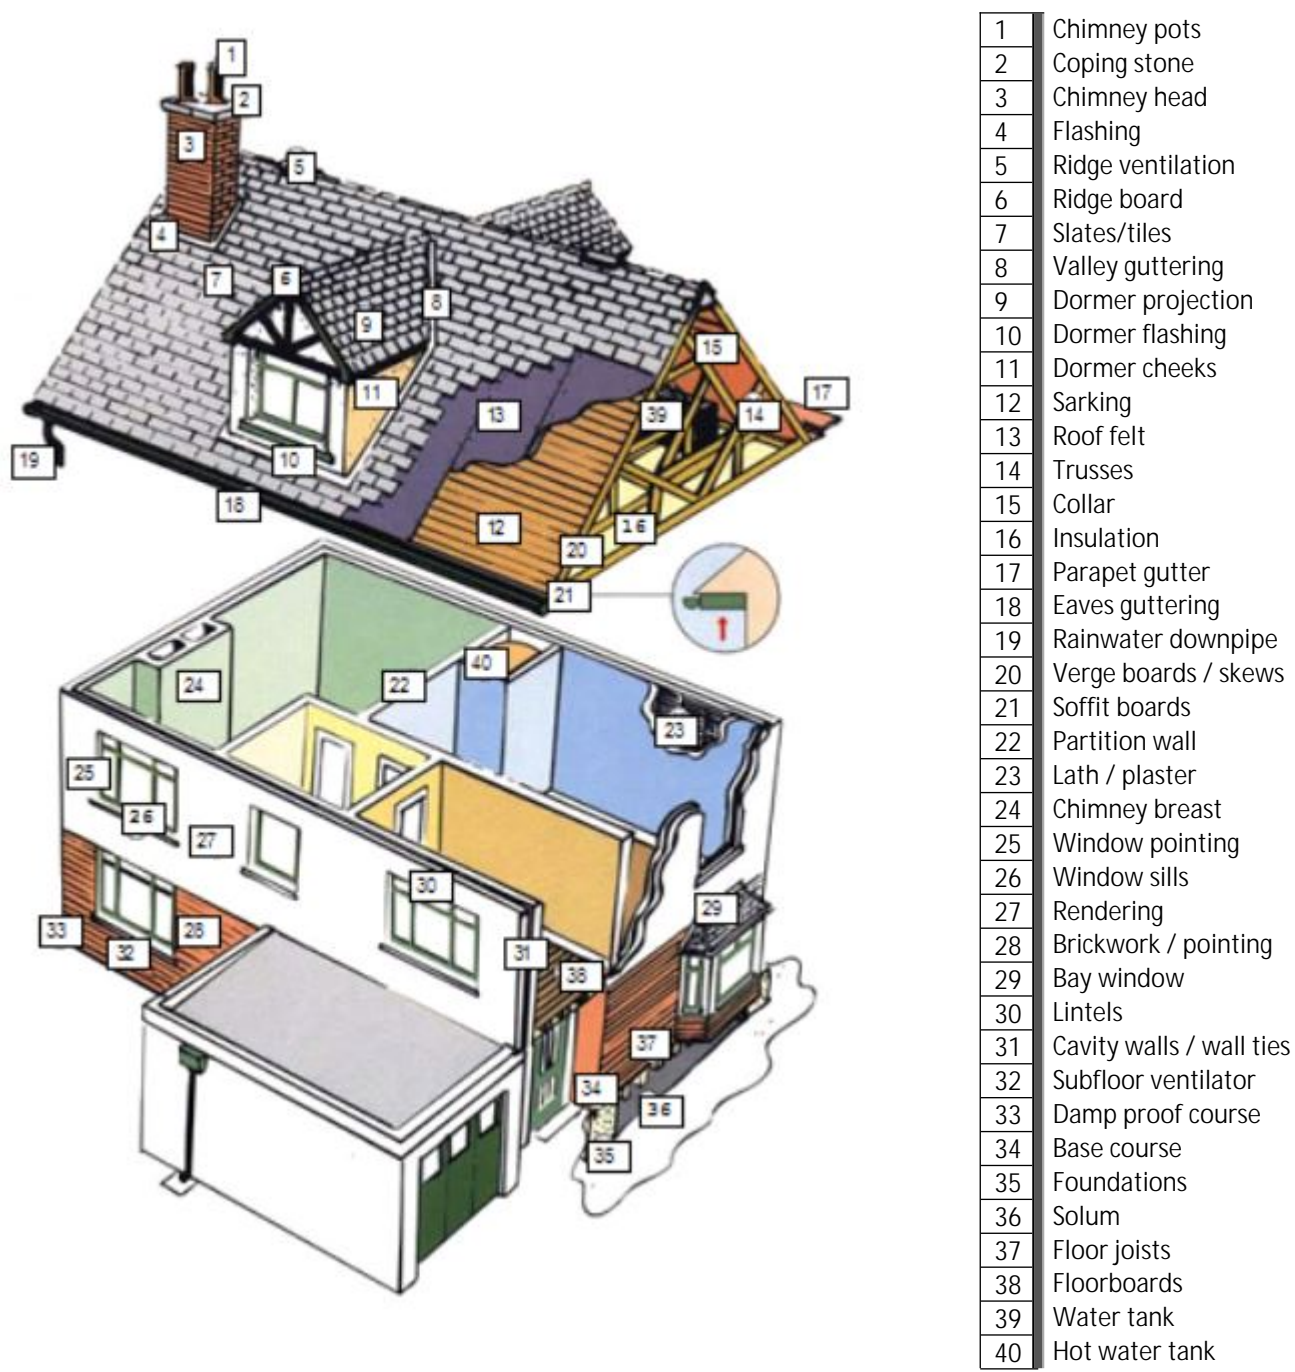
## Sectional Diagram showing elements of a typical house

1	Chimney pots
2	Coping stone
3	Chimney head
4	Flashing
5	Ridge ventilation
6	Ridge board
7	Slates/tiles
8	Valley guttering
9	Dormer projection
10	Dormer flashing
11	Dormer cheeks
12	Sarking
13	Roof felt
14	Trusses
15	Collar
16	Insulation
17	Parapet gutter
18	Eaves guttering
19	Rainwater downpipe
20	Verge boards / skewes
21	Soffit boards
22	Partition wall
23	Lath / plaster
24	Chimney breast
25	Window pointing
26	Window sills
27	Rendering
28	Brickwork / pointing
29	Bay window
30	Lintels
31	Cavity walls / wall ties
32	Subfloor ventilator
33	Damp proof course
34	Base course
35	Foundations
36	Solum
37	Floor joists
38	Floorboards
39	Water tank
40	Hot water tank

Reference may be made in this report to some or all of the above component parts of the property. This diagram may assist you in locating and understanding these items.

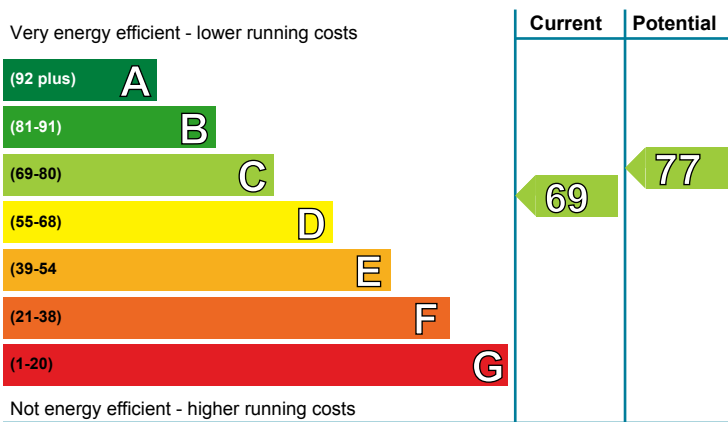
## Energy Efficiency Rating

This graph shows the current efficiency of your home, taking into account both energy efficiency and fuel costs. The higher this rating, the lower your fuel bills are likely to be.

Your current rating is **band C (69)**. The average rating for EPCs in Scotland is **band D (61)**.

The potential rating shows the effect of undertaking all of the improvement measures listed within your recommendations report.

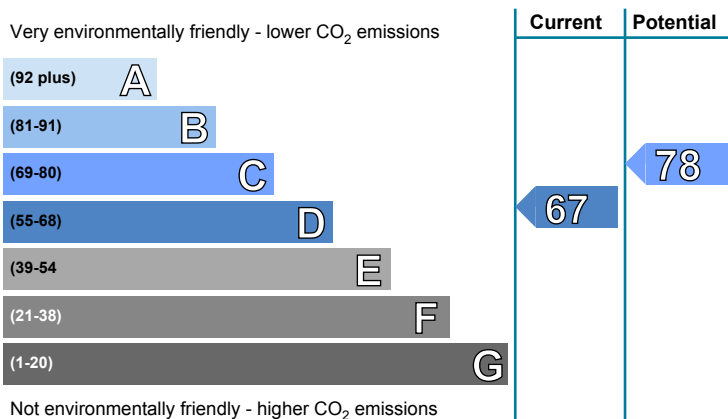
## Environmental Impact (CO<sub>2</sub>) Rating

This graph shows the effect of your home on the environment in terms of carbon dioxide (CO<sub>2</sub>) emissions. The higher the rating, the less impact it has on the environment.
