single survey

survey report on:

Property address	5 Forerow Cottage Caputh Perth PH1 4JE
Customer	Jennifer McLean
Prepared by	Graham + Sibbald LLP

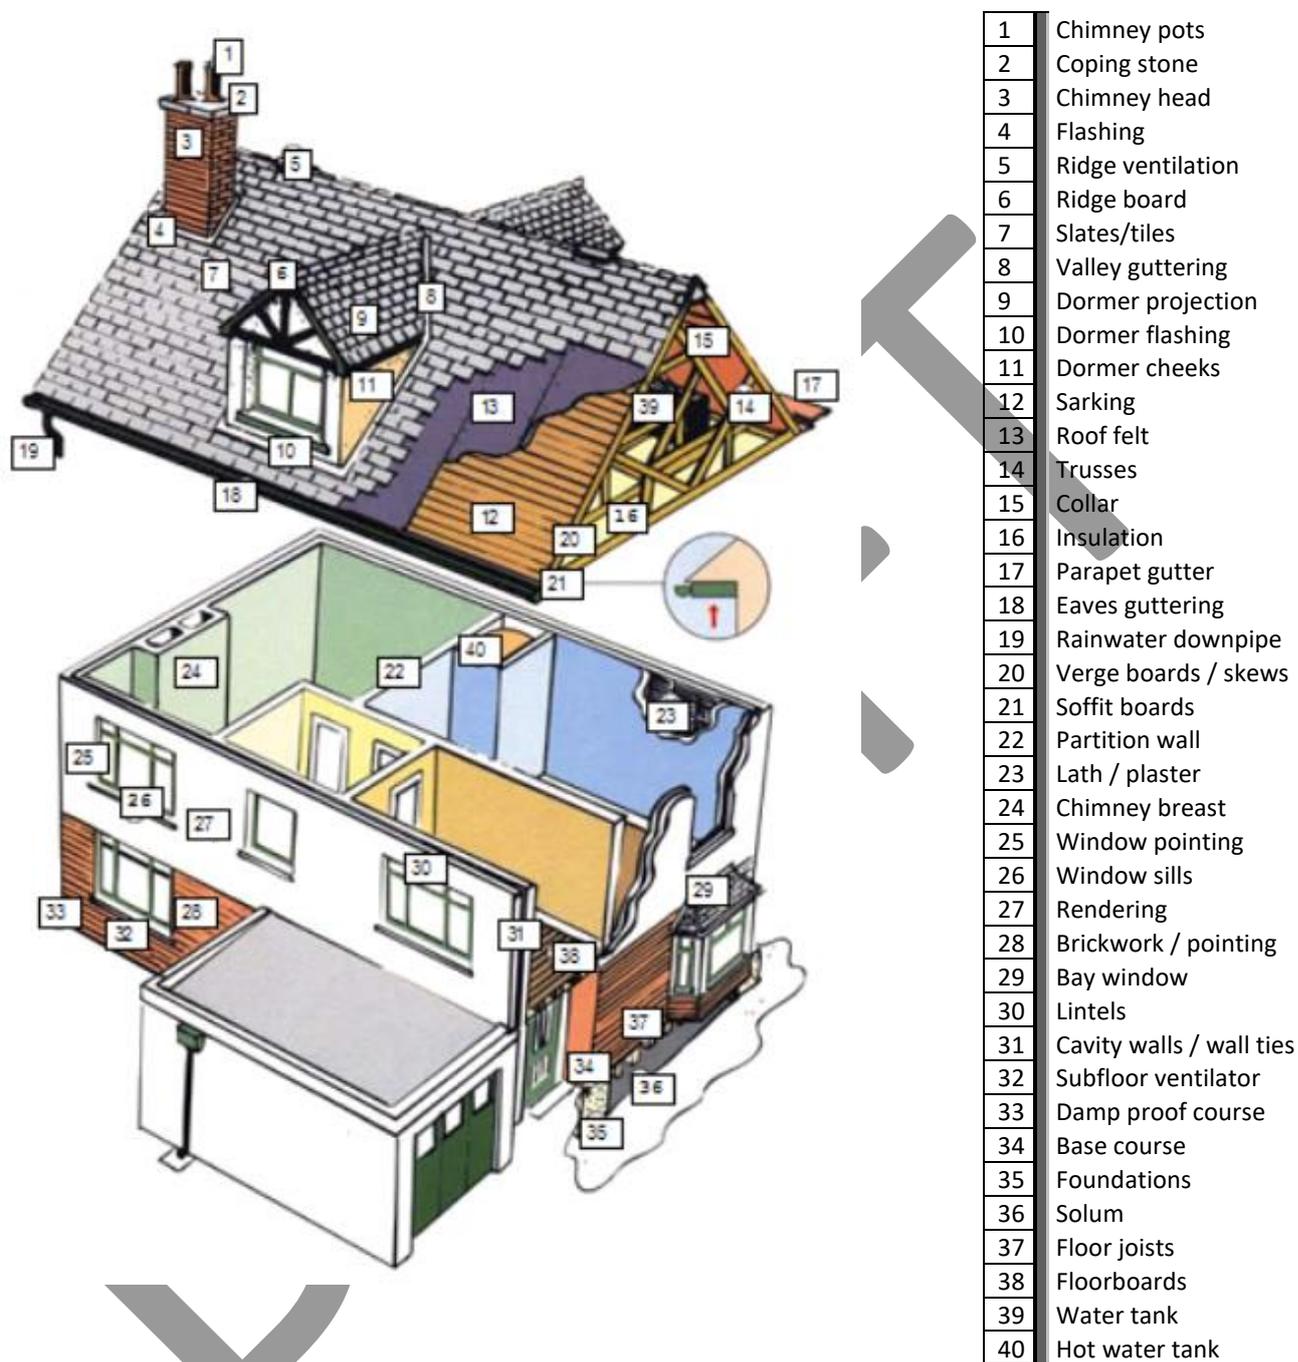
Sectional Diagram showing elements of a typical house

Reference may be made in this report to some or all of the above component parts of the property. This diagram may assist you in locating and understanding these items.
