Home Report

Stapleton Brucefield Road Blairgowrie PH10 6LA

single survey

Prepared by Graham + Sibbald LLP

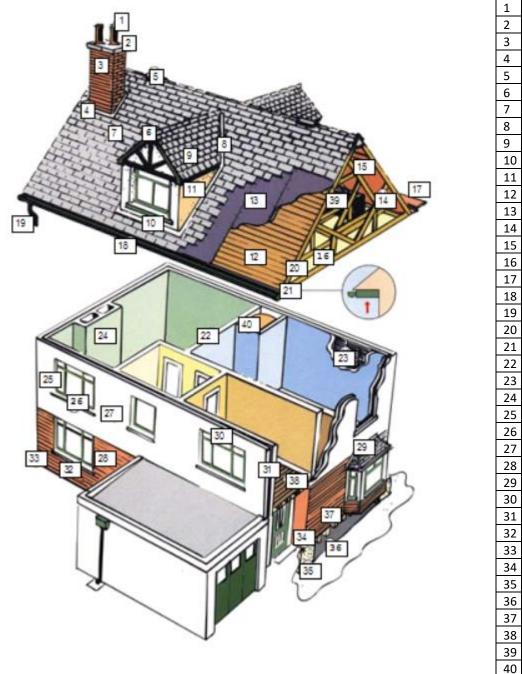
Sectional Diagram showing elements of a typical house

Reference may be made in this report to some or all of the above component parts of the property. This diagram may assist you in locating and understanding these items.
