# Home Report

21 Glenshee Drive  
Rattray  
Blairgowrie  
PH10 7AR

# single survey

<b>Property address</b>	21 Glenshee Drive Ratray Blairgowrie PH10 7AR
<b>Customer</b>	Jonathon + Nicola Archer
<b>Prepared by</b>	Graham + Sibbald LLP

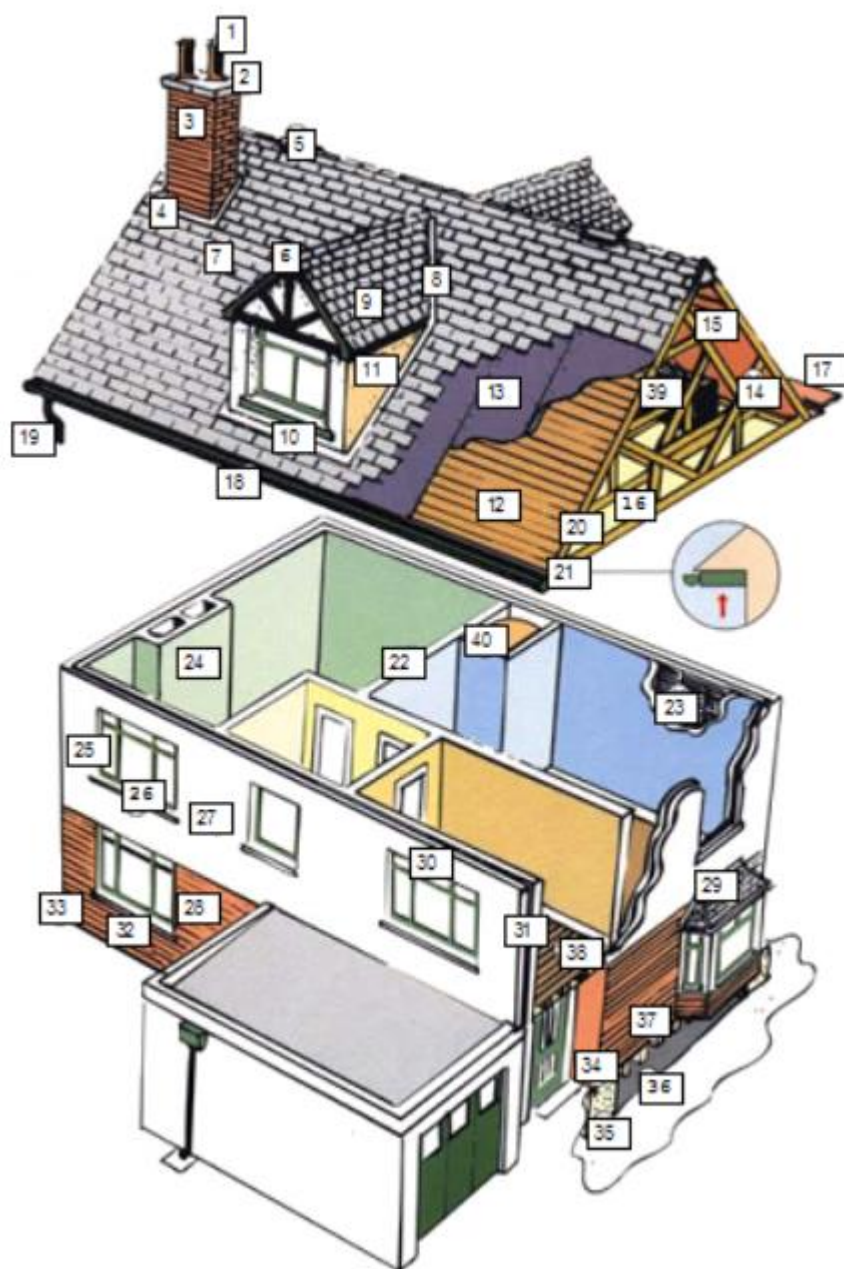
## Sectional Diagram showing elements of a typical house

1	Chimney pots
2	Coping stone
3	Chimney head
4	Flashing
5	Ridge ventilation
6	Ridge board
7	Slates/tiles
8	Valley guttering
9	Dormer projection
10	Dormer flashing
11	Dormer cheeks
12	Sarking
13	Roof felt
14	Trusses
15	Collar
16	Insulation
17	Parapet gutter
18	Eaves guttering
19	Rainwater downpipe
20	Verge boards / skewes
21	Soffit boards
22	Partition wall
23	Lath / plaster
24	Chimney breast
25	Window pointing
26	Window sills
27	Rendering
28	Brickwork / pointing
29	Bay window
30	Lintels
31	Cavity walls / wall ties
32	Subfloor ventilator
33	Damp proof course
34	Base course
35	Foundations
36	Solum
37	Floor joists
38	Floorboards
39	Water tank
40	Hot water tank

Reference may be made in this report to some or all of the above component parts of the property. This diagram may assist you in locating and understanding these items.

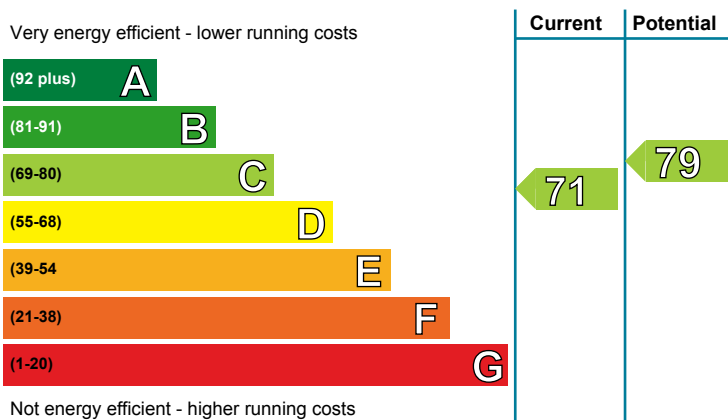
## Energy Efficiency Rating

This graph shows the current efficiency of your home, taking into account both energy efficiency and fuel costs. The higher this rating, the lower your fuel bills are likely to be.

Your current rating is **band C (71)**. The average rating for EPCs in Scotland is **band D (61)**.

The potential rating shows the effect of undertaking all of the improvement measures listed within your recommendations report.

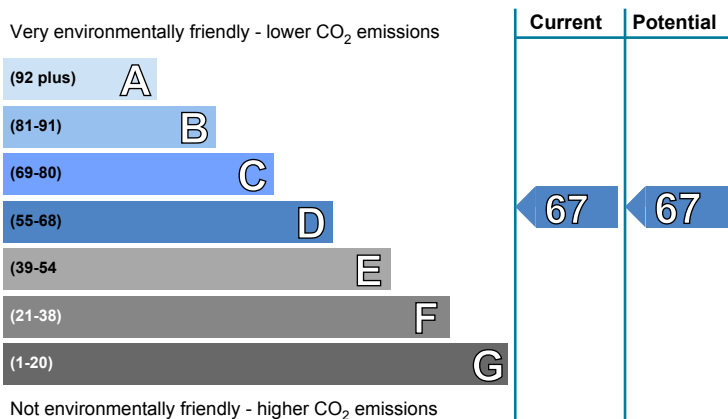
## Environmental Impact (CO<sub>2</sub>) Rating

This graph shows the effect of your home on the environment in terms of carbon dioxide (CO<sub>2</sub>) emissions. The higher the rating, the less impact it has on the environment.
