Home Report

Hope Park Lodge
74 Balmoral Road
Ratray
Blairgowrie
PH10 7AH

single survey

Property address	Hope Park Lodge 74 Balmoral Road Ratray Blairgowrie PH10 7AH
Customer	Mr + Mrs R Pitcher
Prepared by	Graham + Sibbald LLP

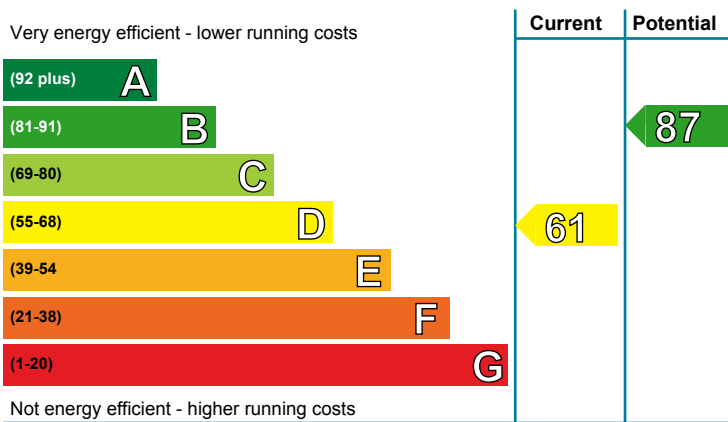
Energy Efficiency Rating

This graph shows the current efficiency of your home, taking into account both energy efficiency and fuel costs. The higher this rating, the lower your fuel bills are likely to be.

Your current rating is **band D (61)**. The average rating for EPCs in Scotland is **band D (61)**.

The potential rating shows the effect of undertaking all of the improvement measures listed within your recommendations report.

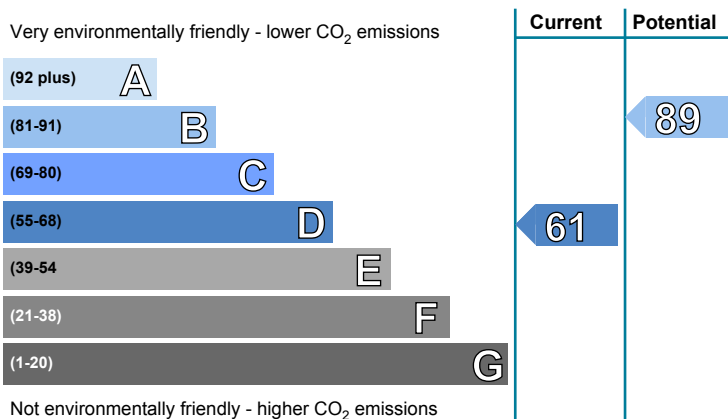
Environmental Impact (CO₂) Rating

This graph shows the effect of your home on the environment in terms of carbon dioxide (CO₂) emissions. The higher the rating, the less impact it has on the environment.
