Home Report

Newray Cottage
Dundee Road
Kettins
Blairgowrie
PH13 9HB

single survey

Property address	Newray Cottage Dundee Road Kettins Blairgowrie PH13 9HB
Customer	Mrs Elizabeth Muir
Prepared by	Graham + Sibbald LLP

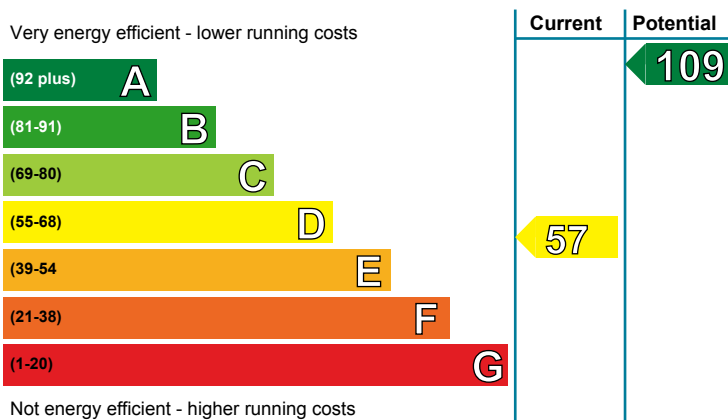
Energy Efficiency Rating

This graph shows the current efficiency of your home, taking into account both energy efficiency and fuel costs. The higher this rating, the lower your fuel bills are likely to be.

Your current rating is **band D (57)**. The average rating for EPCs in Scotland is **band D (61)**.

The potential rating shows the effect of undertaking all of the improvement measures listed within your recommendations report.

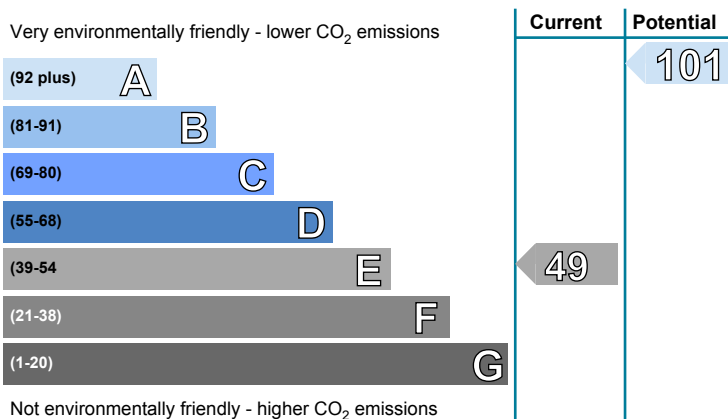
Environmental Impact (CO₂) Rating

This graph shows the effect of your home on the environment in terms of carbon dioxide (CO₂) emissions. The higher the rating, the less impact it has on the environment.
