# Home Report

2 Castle Street  
Blairgowrie  
PH10 6DR

# single survey

<b>Property address</b>	2 Castle Street Blairgowrie PH10 6DR
<b>Customer</b>	Executry of the late Kenneth Dow
<b>Prepared by</b>	Graham + Sibbald LLP

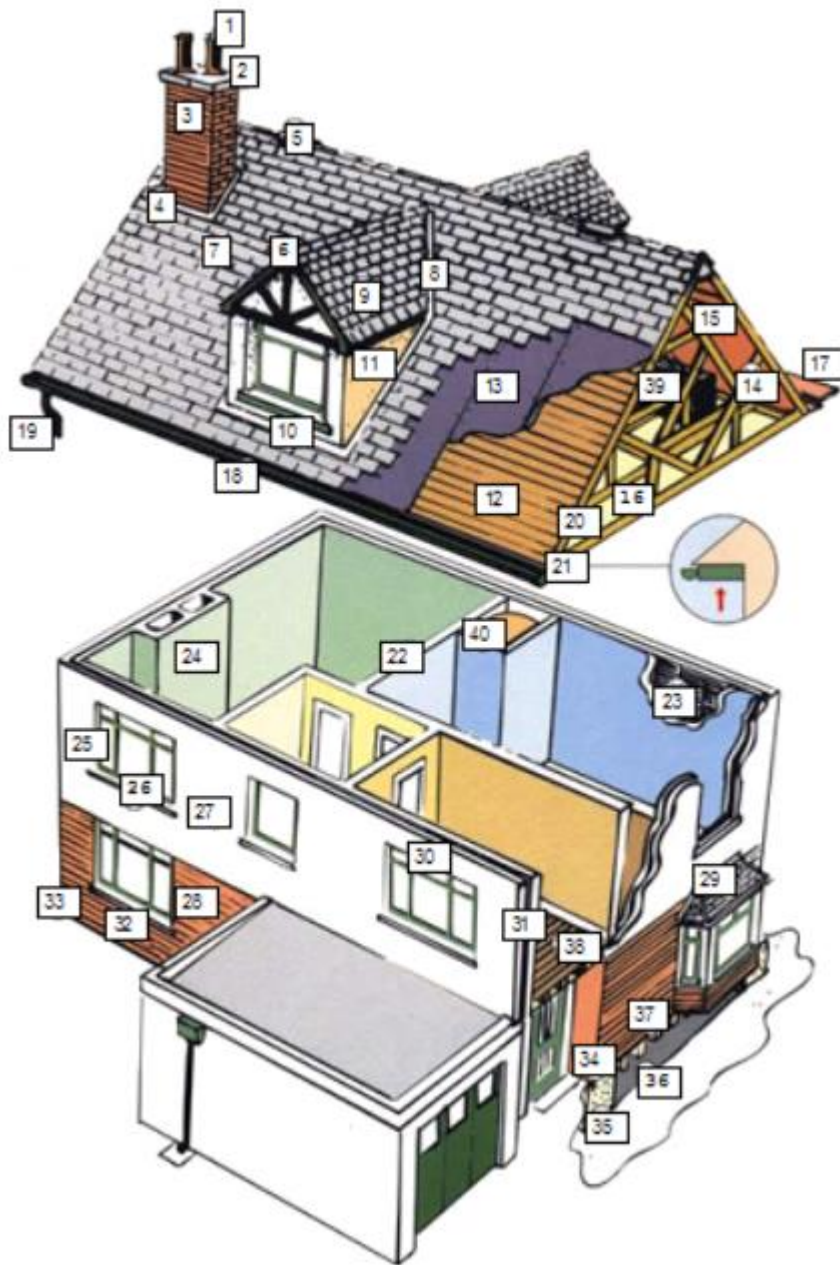
## Sectional Diagram showing elements of a typical house

1	Chimney pots
2	Coping stone
3	Chimney head
4	Flashing
5	Ridge ventilation
6	Ridge board
7	Slates/tiles
8	Valley guttering
9	Dormer projection
10	Dormer flashing
11	Dormer cheeks
12	Sarking
13	Roof felt
14	Trusses
15	Collar
16	Insulation
17	Parapet gutter
18	Eaves guttering
19	Rainwater downpipe
20	Verge boards / skewes
21	Soffit boards
22	Partition wall
23	Lath / plaster
24	Chimney breast
25	Window pointing
26	Window sills
27	Rendering
28	Brickwork / pointing
29	Bay window
30	Lintels
31	Cavity walls / wall ties
32	Subfloor ventilator
33	Damp proof course
34	Base course
35	Foundations
36	Solum
37	Floor joists
38	Floorboards
39	Water tank
40	Hot water tank

Reference may be made in this report to some or all of the above component parts of the property. This diagram may assist you in locating and understanding these items.

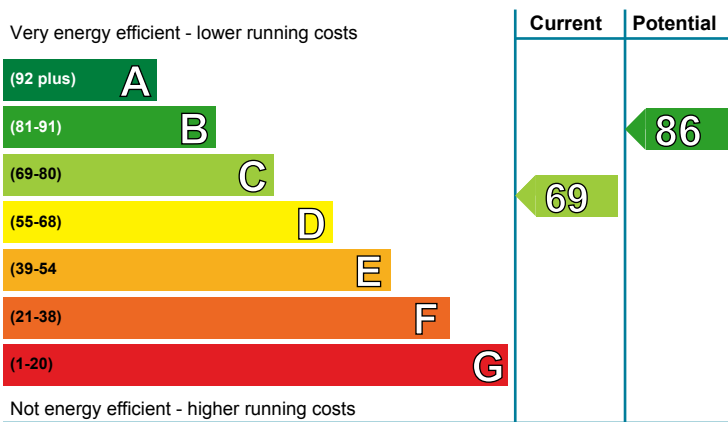
## Energy Efficiency Rating

This graph shows the current efficiency of your home, taking into account both energy efficiency and fuel costs. The higher this rating, the lower your fuel bills are likely to be.

Your current rating is **band C (69)**. The average rating for EPCs in Scotland is **band D (61)**.

The potential rating shows the effect of undertaking all of the improvement measures listed within your recommendations report.

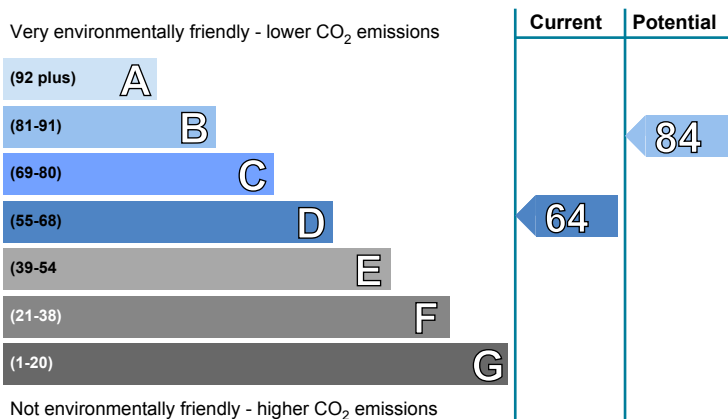
## Environmental Impact (CO<sub>2</sub>) Rating

This graph shows the effect of your home on the environment in terms of carbon dioxide (CO<sub>2</sub>) emissions. The higher the rating, the less impact it has on the environment.
