Home Report

Flat A 22 John Street
Blairgowrie PH10 6DG

Date of Valuation: 07/06/2024

Property address	Flat A 22 John Street Blairgowrie PH10 6DG
Customer	The Executor of Angus Reid
Prepared by	Graham + Sibbald LLP

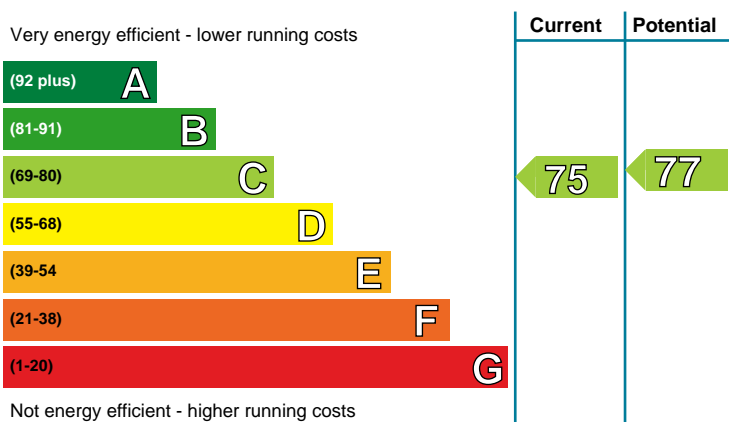
Energy Efficiency Rating

This graph shows the current efficiency of your home, taking into account both energy efficiency and fuel costs. The higher this rating, the lower your fuel bills are likely to be.

Your current rating is **band C (75)**. The average rating for EPCs in Scotland is **band D (61)**.

The potential rating shows the effect of undertaking all of the improvement measures listed within your recommendations report.
