# Home Report

52 Perth Street  
Blairgowrie PH10 6DL

# single survey

Property address	52 Perth Street Blairgowrie PH10 6DL
------------------	--

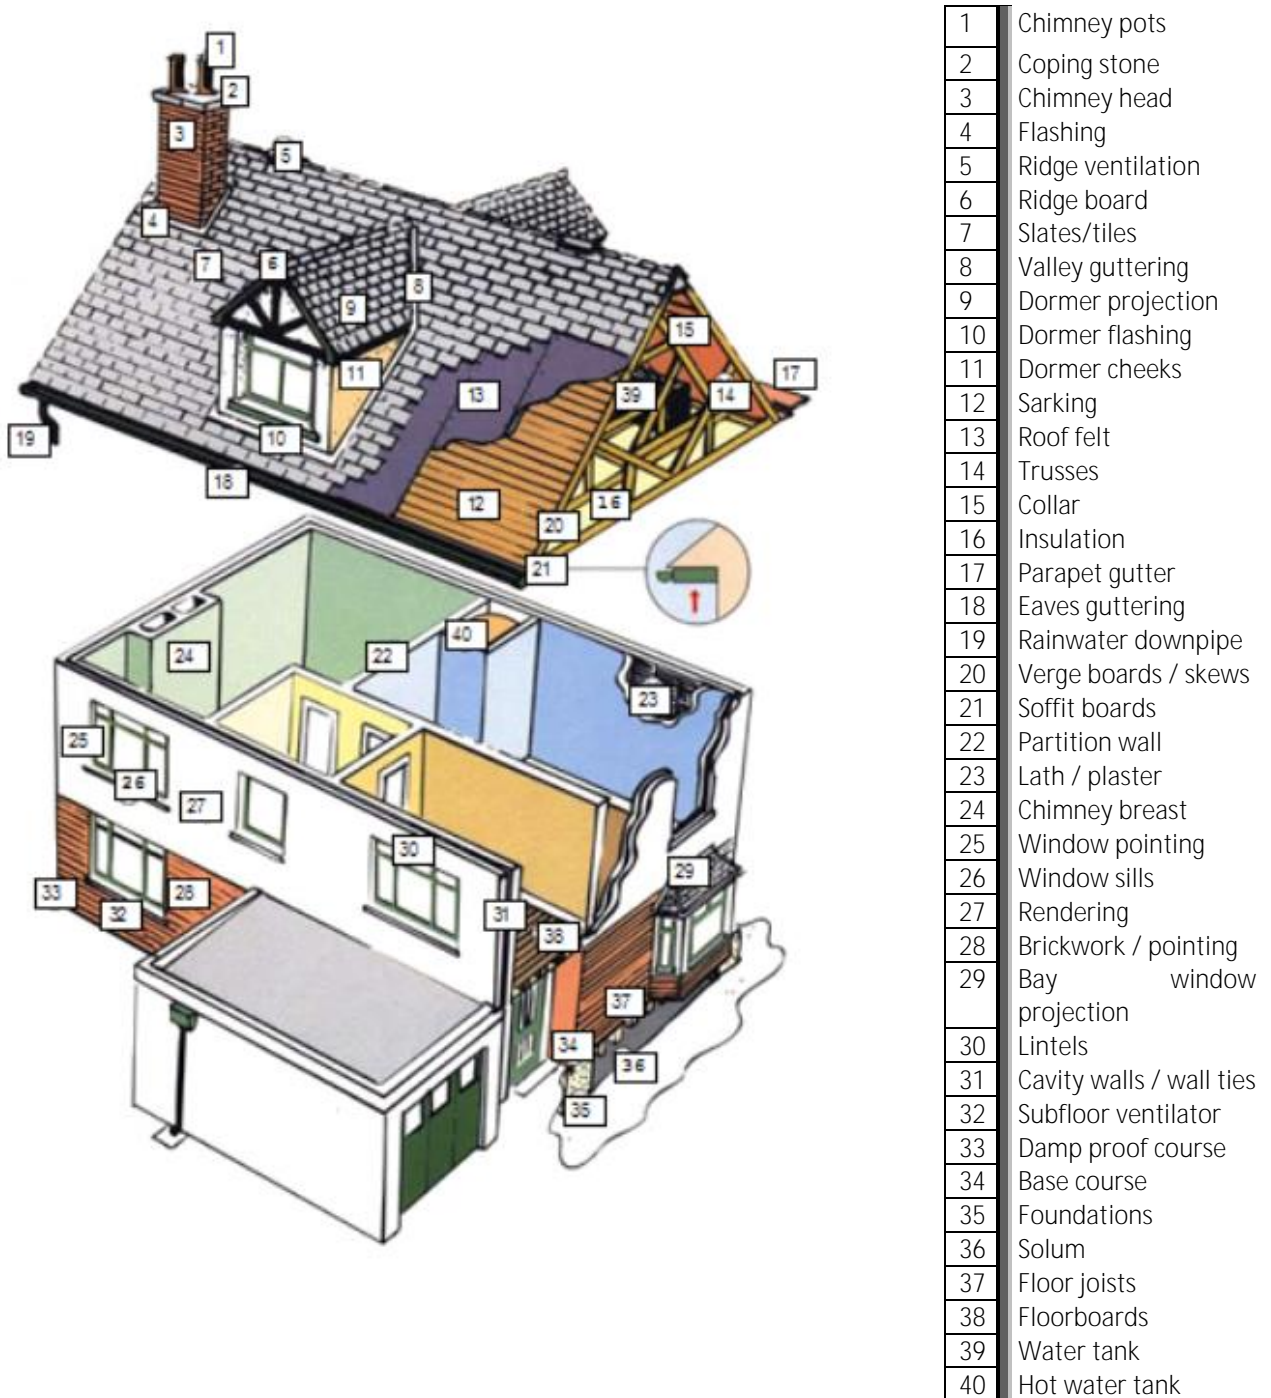
## Sectional Diagram showing elements of a typical house

Reference may be made in this report to some or all of the above component parts of the property. This diagram may assist you in locating and understanding these items.

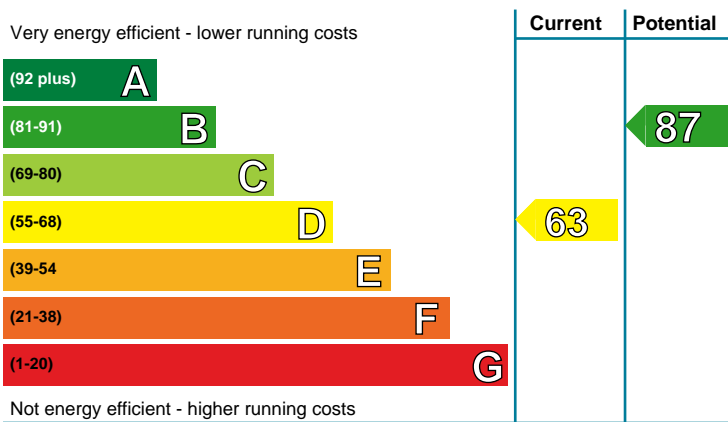
## Energy Efficiency Rating

This graph shows the current efficiency of your home, taking into account both energy efficiency and fuel costs. The higher this rating, the lower your fuel bills are likely to be.

Your current rating is **band D (63)**. The average rating for EPCs in Scotland is **band D (61)**.

The potential rating shows the effect of undertaking all of the improvement measures listed within your recommendations report.
