# Home Report

Hill View  
Ballintuim PH10 7NJ

# single survey

| Prepared by | Graham + Sibbald LLP |

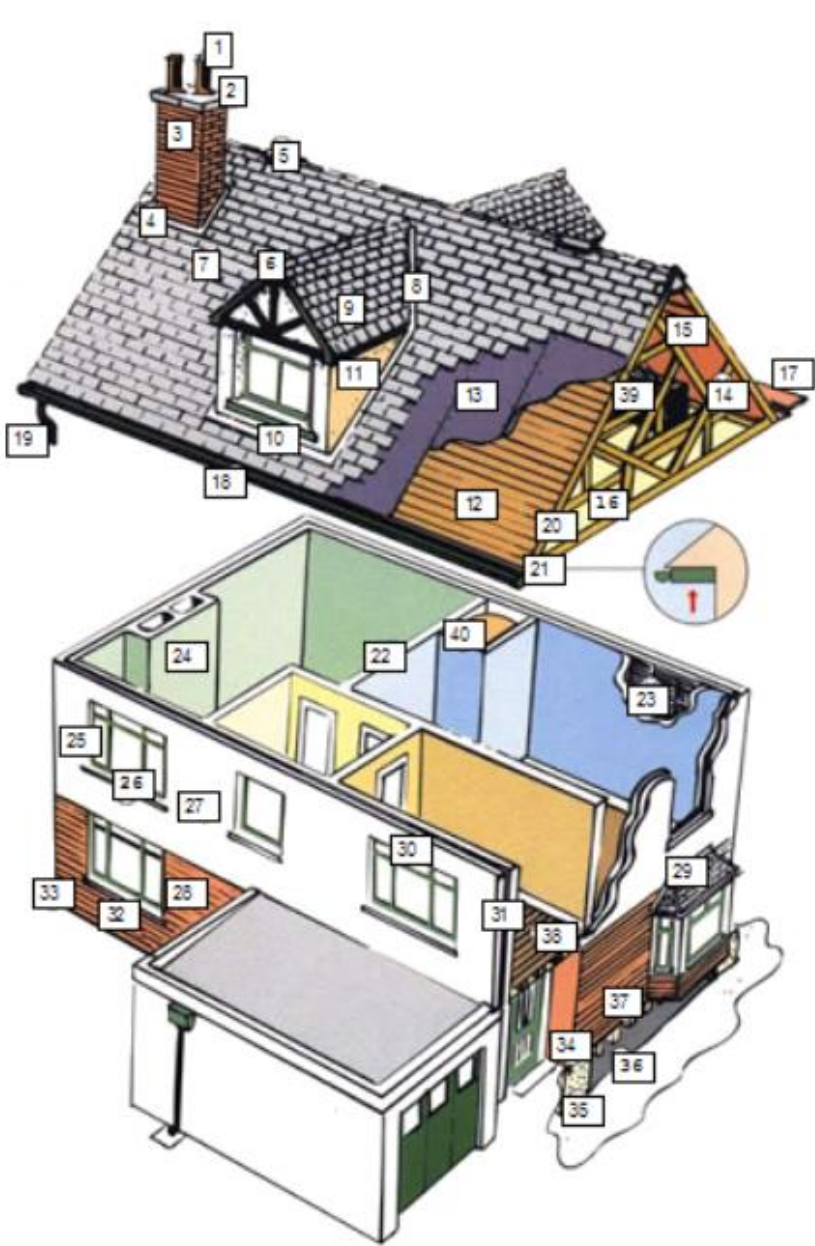
# Sectional Diagram showing elements of a typical house

| 1 | Chimney pots |
| 35 | Foundations |

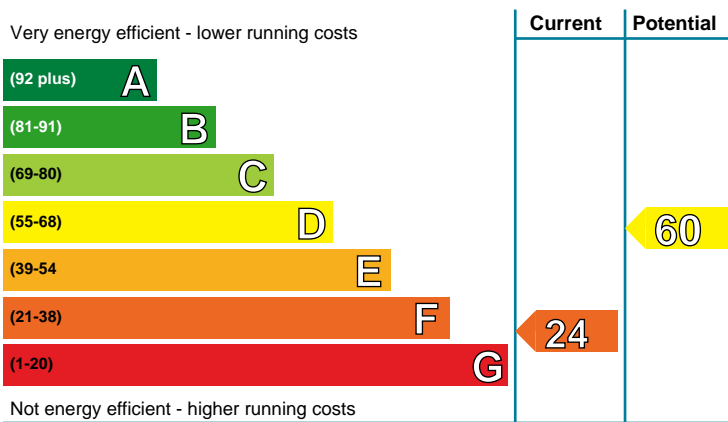
## Energy Efficiency Rating

This graph shows the current efficiency of your home, taking into account both energy efficiency and fuel costs. The higher this rating, the lower your fuel bills are likely to be.

Your current rating is **band F (24)**. The average rating for EPCs in Scotland is **band D (61)**.

The potential rating shows the effect of undertaking all of the improvement measures listed within your recommendations report.
