# Home Report

Church Cottage  
Kettins Blairgowrie PH13 9JL

# Single Survey

| <b>Prepared by</b> | Graham + Sibbald Property Consultants Limited |

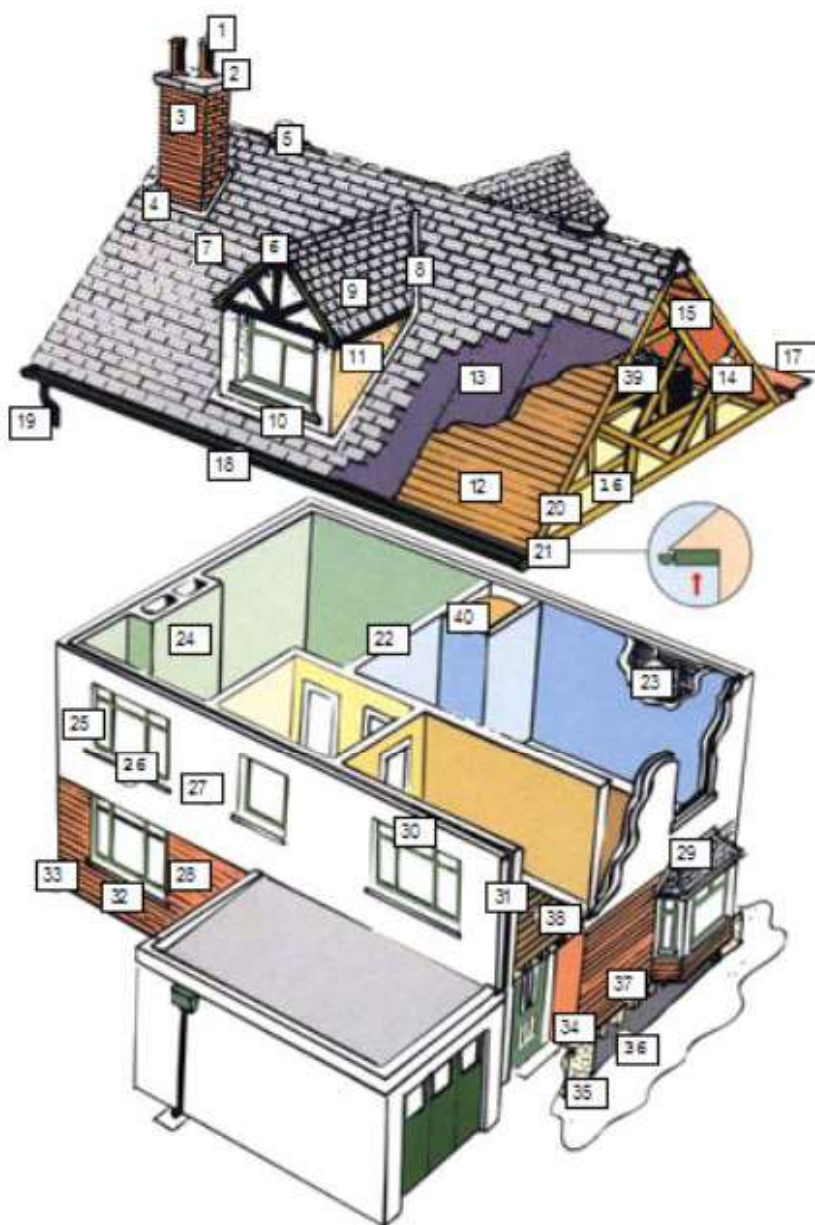
## Sectional diagram showing elements of a typical house

| 1 | Chimney pots |
| 2 | Coping stone |
| 35 | Foundations |

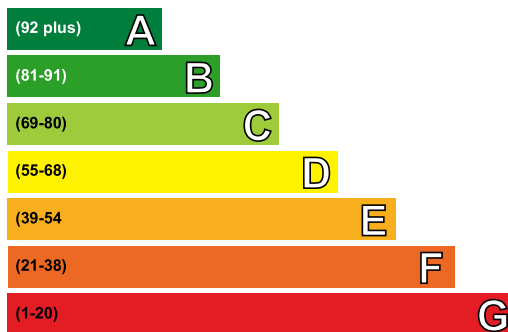
Very energy efficient - lower running costs

Not energy efficient - higher running costs

| Current | Potential |

The potential rating shows the effect of undertaking all of the improvement measures listed within your recommendations report.

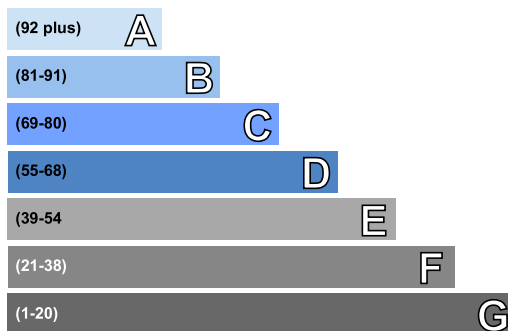
Very environmentally friendly - lower CO<sub>2</sub> emissions

Not environmentally friendly - higher CO<sub>2</sub> emissions

| Current | Potential |
