# Home Report

Ridgeway Wester Essendy  
Blairgowrie PH10 6RA

# Single Survey

<b>Property Address</b>	Ridgeway Wester Essendy Blairgowrie PH10 6RA
<b>Customer</b>	Pamela Mathews
<b>Prepared by</b>	Graham + Sibbald Property Consultants Limited
<b>Date of Inspection</b>	12/02/2026

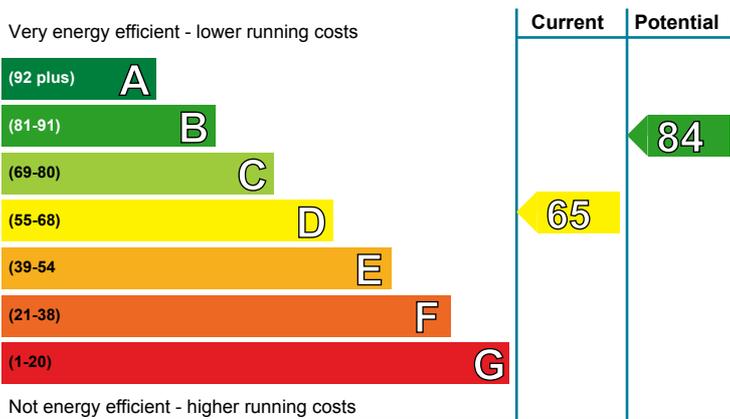
## Energy Efficiency Rating

This graph shows the current efficiency of your home, taking into account both energy efficiency and fuel costs. The higher this rating, the lower your fuel bills are likely to be.

Your current rating is **band D (65)**. The average rating for EPCs in Scotland is **band D (61)**.

The potential rating shows the effect of undertaking all of the improvement measures listed within your recommendations report.

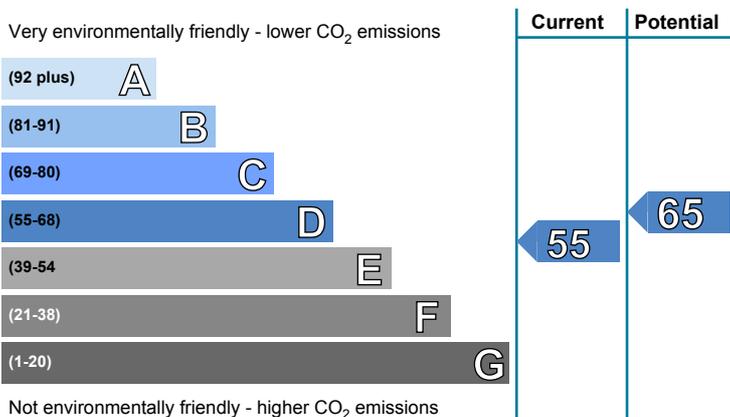
## Environmental Impact (CO<sub>2</sub>) Rating

This graph shows the effect of your home on the environment in terms of carbon dioxide (CO<sub>2</sub>) emissions. The higher the rating, the less impact it has on the environment.
