# Home Report

Marnoch Middle Road  
Ratray Blairgowrie PH10 7EL

# Single Survey

<b>Property Address</b>	Marnoch Middle Road Ratray Blairgowrie PH10 7EL
<b>Customer</b>	Jill Bowen
<b>Prepared by</b>	Graham + Sibbald Property Consultants Limited
<b>Date of Inspection</b>	25/02/2026

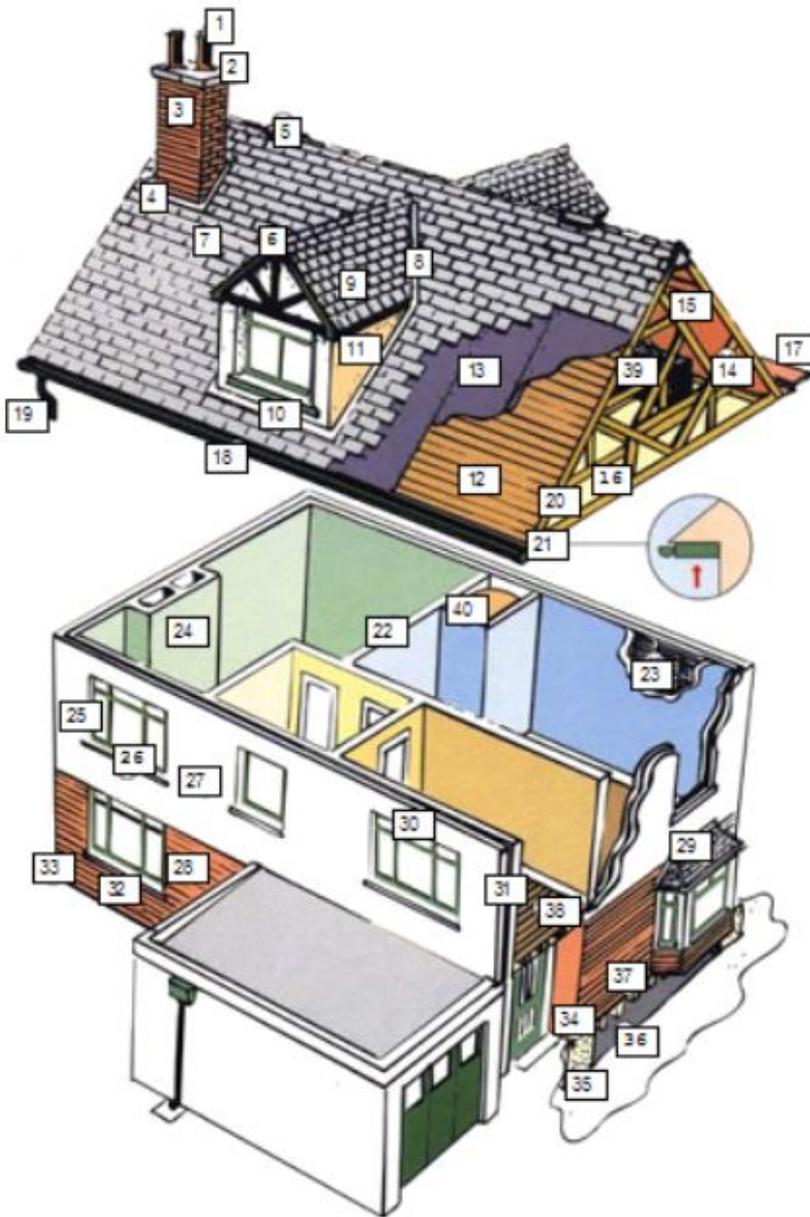
## Sectional diagram showing elements of a typical house

1	Chimney pots
2	Coping stone
3	Chimney head
4	Flashing
5	Ridge ventilation
6	Ridge board
7	Slates / tiles
8	Valley guttering
9	Dormer projection
10	Dormer flashing
11	Dormer cheeks
12	Sarking
13	Roof felt
14	Trusses
15	Collar
16	Insulation
17	Parapet gutter
18	Eaves guttering
19	Rainwater downpipe
20	Verge boards / skews
21	Soffit boards
22	Partition wall
23	Lath / plaster
24	Chimney breast
25	Window pointing
26	Window sills
27	Rendering
28	Brickwork / pointing
29	Bay window projection
30	Lintels
31	Cavity walls / wall ties
32	Subfloor ventilator
33	Damp proof course
34	Base course
35	Foundations
36	Solum
37	Floor joists
38	Floorboards
39	Water tank
40	Hot water tank

Reference may be made in this report to some or all of the above component parts of the property. This diagram may assist you in locating and understanding these items.

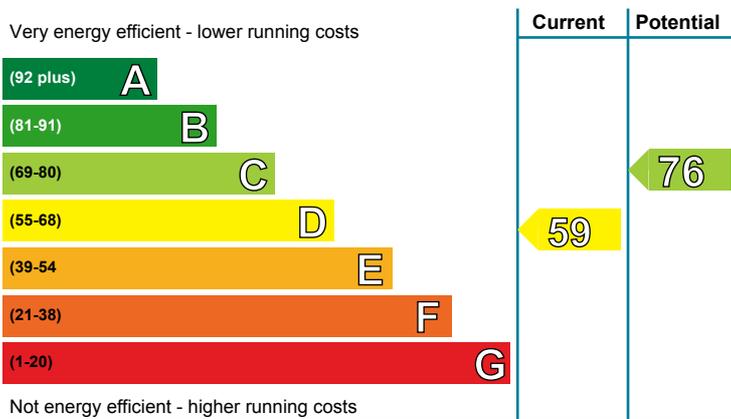
## Energy Efficiency Rating

This graph shows the current efficiency of your home, taking into account both energy efficiency and fuel costs. The higher this rating, the lower your fuel bills are likely to be.

Your current rating is **band D (59)**. The average rating for EPCs in Scotland is **band D (61)**.

The potential rating shows the effect of undertaking all of the improvement measures listed within your recommendations report.

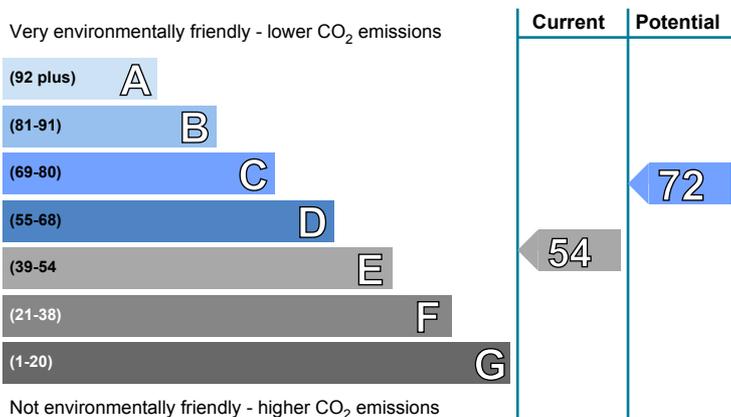
## Environmental Impact (CO<sub>2</sub>) Rating

This graph shows the effect of your home on the environment in terms of carbon dioxide (CO<sub>2</sub>) emissions. The higher the rating, the less impact it has on the environment.
