Home Report

Parkville Airlie Place
Alyth Blairgowrie PH11 8EG

Single Survey

Property Address	Parkville Airlie Place Alyth Blairgowrie PH11 8EG
Customer	Sandra Lyle
Prepared by	Graham + Sibbald Property Consultants Limited
Date of Inspection	06/04/2026

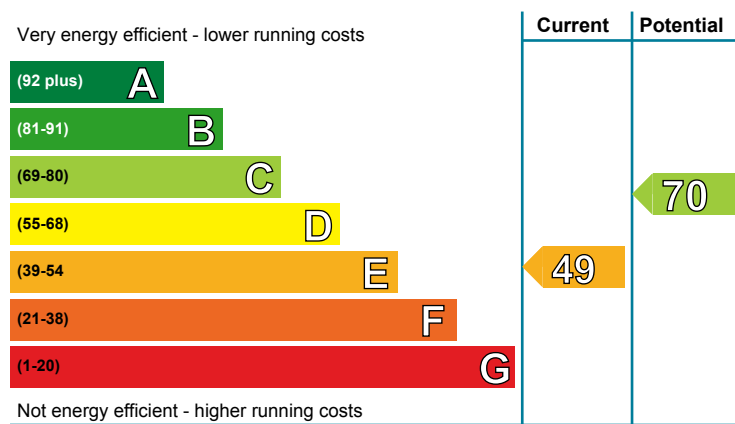
Energy Efficiency Rating

This graph shows the current efficiency of your home, taking into account both energy efficiency and fuel costs. The higher this rating, the lower your fuel bills are likely to be.

Your current rating is **band E (49)**. The average rating for EPCs in Scotland is **band D (61)**.

The potential rating shows the effect of undertaking all of the improvement measures listed within your recommendations report.
