Home Report

Willowburn Cottage
Kinloch PH10 6SD

Single Survey

Property Address	Willowburn Cottage Kinloch PH10 6SD
Customer	Una Berry
Prepared by	Graham + Sibbald Property Consultants Limited
Date of Inspection	22/04/2026

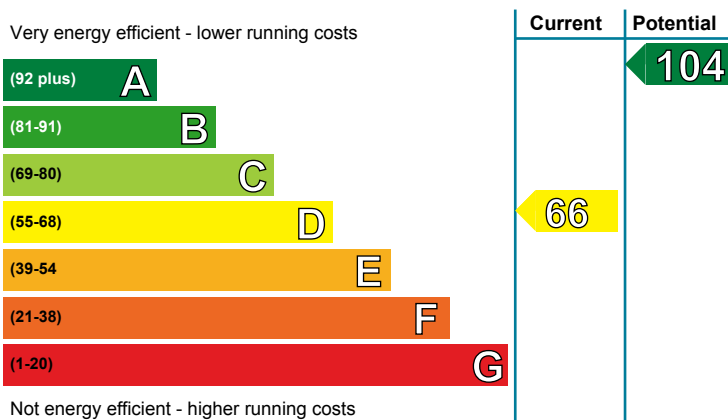
Energy Efficiency Rating

This graph shows the current efficiency of your home, taking into account both energy efficiency and fuel costs. The higher this rating, the lower your fuel bills are likely to be.

Your current rating is **band D (66)**. The average rating for EPCs in Scotland is **band D (61)**.

The potential rating shows the effect of undertaking all of the improvement measures listed within your recommendations report.
