Home Report

The Sheiling Townhead
Coupar Angus Blairgowrie PH13 9AR

Single Survey

Property Address	The Sheiling Townhead Coupar Angus Blairgowrie PH13 9AR
Customer	Murray Bullions
Prepared by	Graham + Sibbald Property Consultants Limited
Date of Inspection	21/05/2026

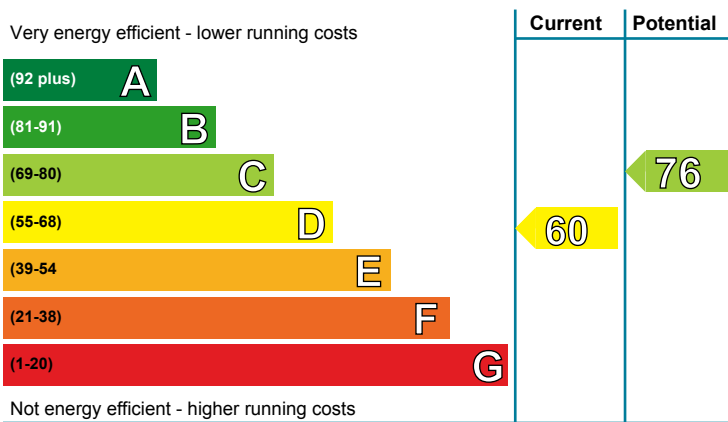
Energy Efficiency Rating

This graph shows the current efficiency of your home, taking into account both energy efficiency and fuel costs. The higher this rating, the lower your fuel bills are likely to be.

Your current rating is **band D (60)**. The average rating for EPCs in Scotland is **band D (61)**.

The potential rating shows the effect of undertaking all of the improvement measures listed within your recommendations report.

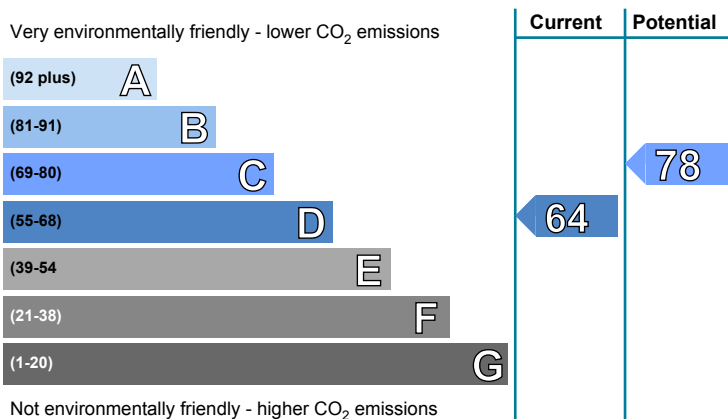
Environmental Impact (CO₂) Rating

This graph shows the effect of your home on the environment in terms of carbon dioxide (CO₂) emissions. The higher the rating, the less impact it has on the environment.
