Home Report

Scottish Single Survey

Property address	55 Perth Street Blairgowrie PH10 6DL
Customer	Brian Lundie
Customer address	
Prepared by	Shepherd Chartered Surveyors
Date of inspection	28/05/2026

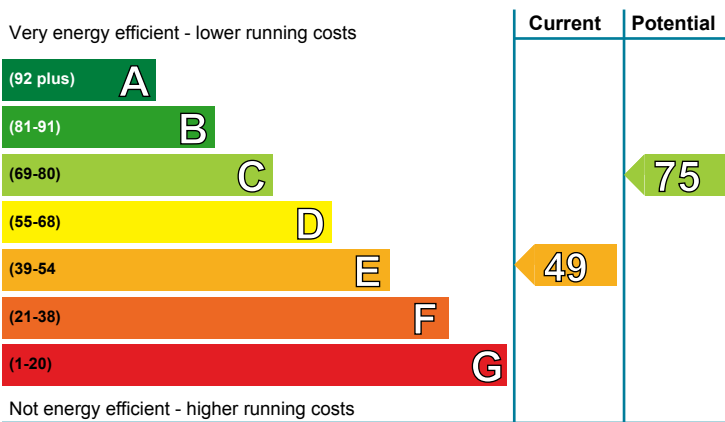
Energy Efficiency Rating

This graph shows the current efficiency of your home, taking into account both energy efficiency and fuel costs. The higher this rating, the lower your fuel bills are likely to be.

Your current rating is **band E (49)**. The average rating for EPCs in Scotland is **band D (61)**.

The potential rating shows the effect of undertaking all of the improvement measures listed within your recommendations report.

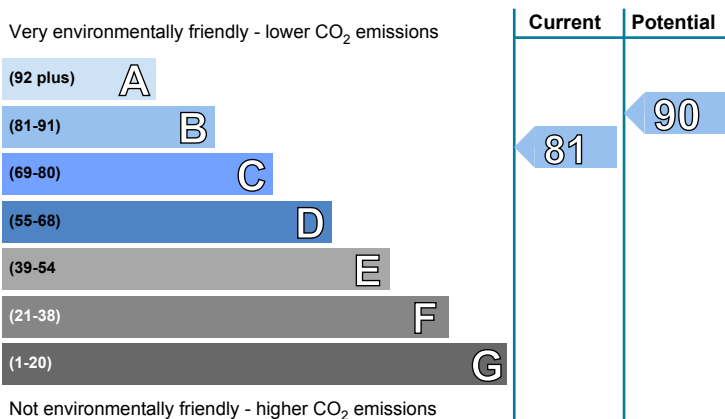
Environmental Impact (CO₂) Rating

This graph shows the effect of your home on the environment in terms of carbon dioxide (CO₂) emissions. The higher the rating, the less impact it has on the environment.
