# Home Report

Craigton Farmhouse Cottage  
Bridge Of Cally PH10 7LH

# Single Survey

| <b>Property Address</b> | Craigton Farmhouse Cottage<br>Bridge Of Cally<br>PH10 7LH |

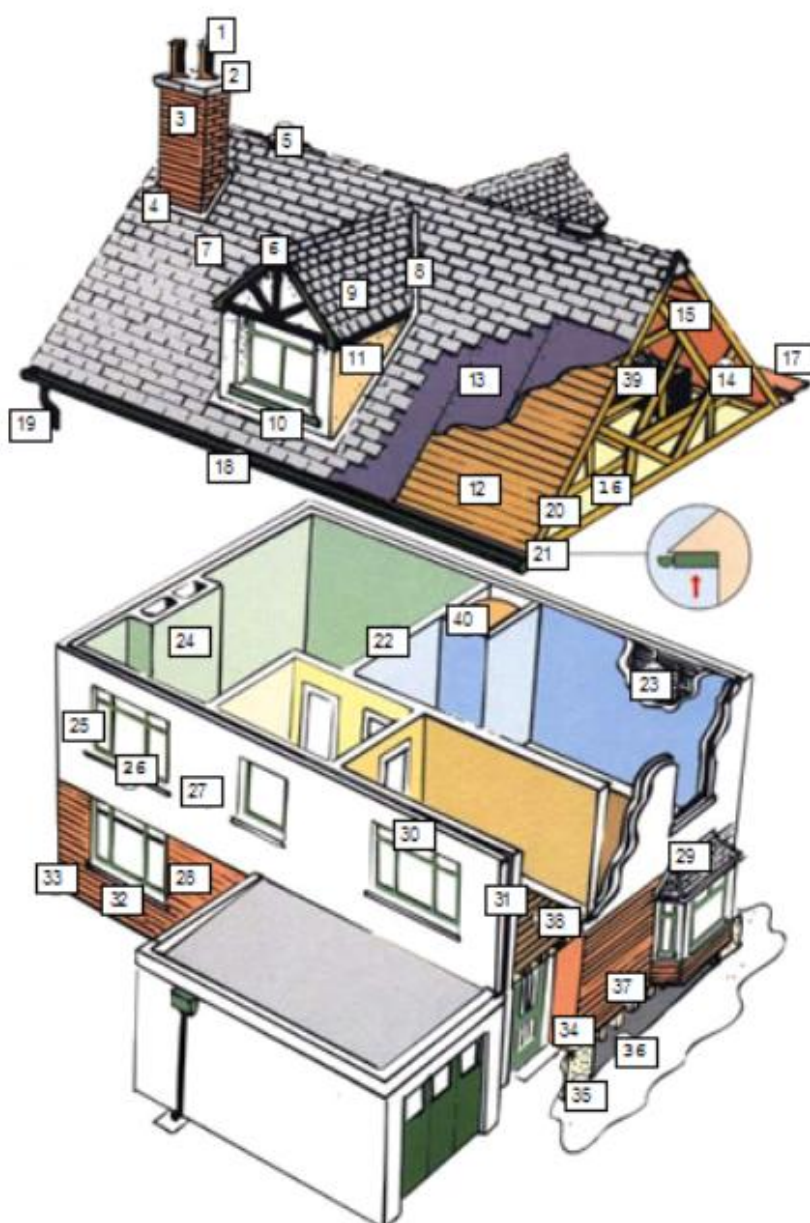
## Sectional diagram showing elements of a typical house

| 1 | Chimney pots |
| 2 | Coping stone |
| 35 | Foundations |
