# Home Report

Fernbank High Street  
Ratray Blairgowrie PH10 7DE

# Single Survey

| Prepared by | Graham + Sibbald Property Consultants Limited |

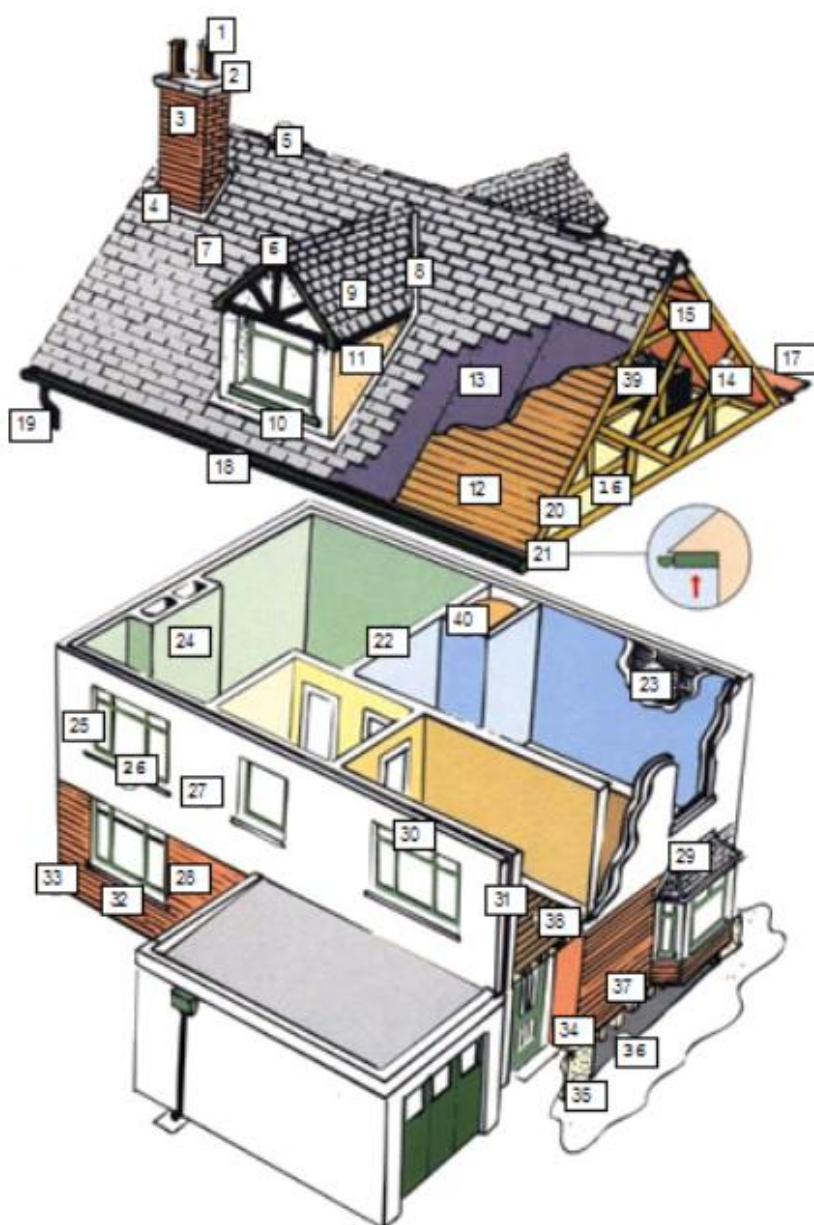
## Sectional diagram showing elements of a typical house

| 1 | Chimney pots |
| 2 | Coping stone |
| 35 | Foundations |

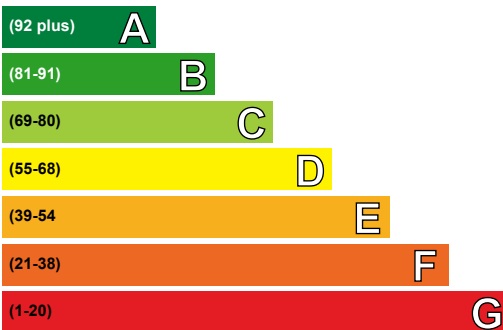
\* based upon the cost of energy for heating, hot water, lighting and ventilation, calculated using standard assumptions

Very energy efficient - lower running costs

Not energy efficient - higher running costs

The potential rating shows the effect of undertaking all of the improvement measures listed within your recommendations report.

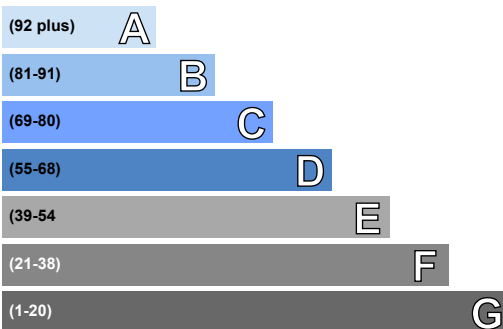
Very environmentally friendly - lower CO<sub>2</sub> emissions

Not environmentally friendly - higher CO<sub>2</sub> emissions
